# Santa Cruz Public Libraries

2013

## Facility Summary and FCI

# Aptos

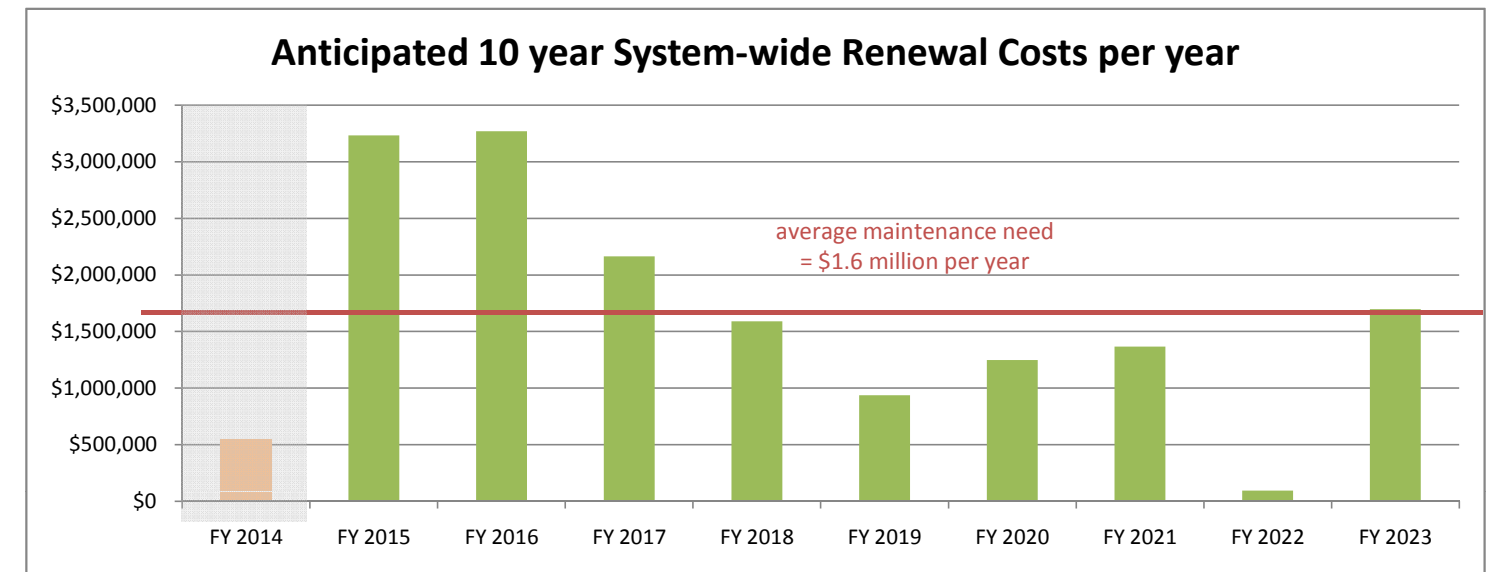
Anticipated 10 year System-wide Renewal Costs per year

FY 2014	FY 2015	FY 2016	FY 2017	FY 2018	FY 2019	FY 2020	FY 2021	FY 2022	FY 2023
\$546,000	\$3,233,000	\$3,269,000	\$2,165,000	\$1,589,000	\$938,000	\$1,249,000	\$1,367,000	\$97,000	\$1,699,000

1. The first year of the renewal plan (2014) addresses only highest priority needs.
